UNITED STATES ENVIRONMENTAL PROTECTION AGENCY
REGION IX – PACIFIC SOUTHWEST REGION
75 Hawthorne Street
San Francisco, CA 94105-3901

Region 9 Enforcement Division
75 Hawthorne Street
San Francisco, CA 94105
INSPECTION REPORT

Inspection Date:	12/10/2015		
Time:	Entry: 8:25 a.m.	Exit: 11:30 a.m.	
Media:	Water		
Regulatory Program:	CWA NPDES/Industrial Storm Water		
Company Name:	Direct Pack, Inc.		
Facility or Site Name:	PMC Direct Pack, Inc.		
Facility/Site Physical Location:	12243 Branford Street		
(city, state, zip code)	Sun Valley, CA 91352		
Geographic Coordinates:	34°15'4.54"N, 118°24'2.09"W		
Facility/Site Contact:	Luis Mendoza	Facilities Manager	
	818-896-1101		
County:	Los Angeles County		
Facility/Site Identifier:	CA WDID#: 4 19I25619		
NPDES Number:	CAS000001		
SWRCB Order Number:	2014-0057-DWQ		
SIC Code:	3081 – Unsupported Plastics Film and Sheet		
Facility/Site Personnel Participating in Inspection:			
Luis Mendoza	Facilities Manager	818-896-1101	
Mr. Patrick Ahuero	Plant Manager	Not provided	
Inspector(s):			
Kettie Holland (Lead & Report Author)	PG Environmental, LLC	US EPA Contract Inspector	303-279-1778
Signature: <i>Kettie J. Holland</i>	Date: 1/22/16

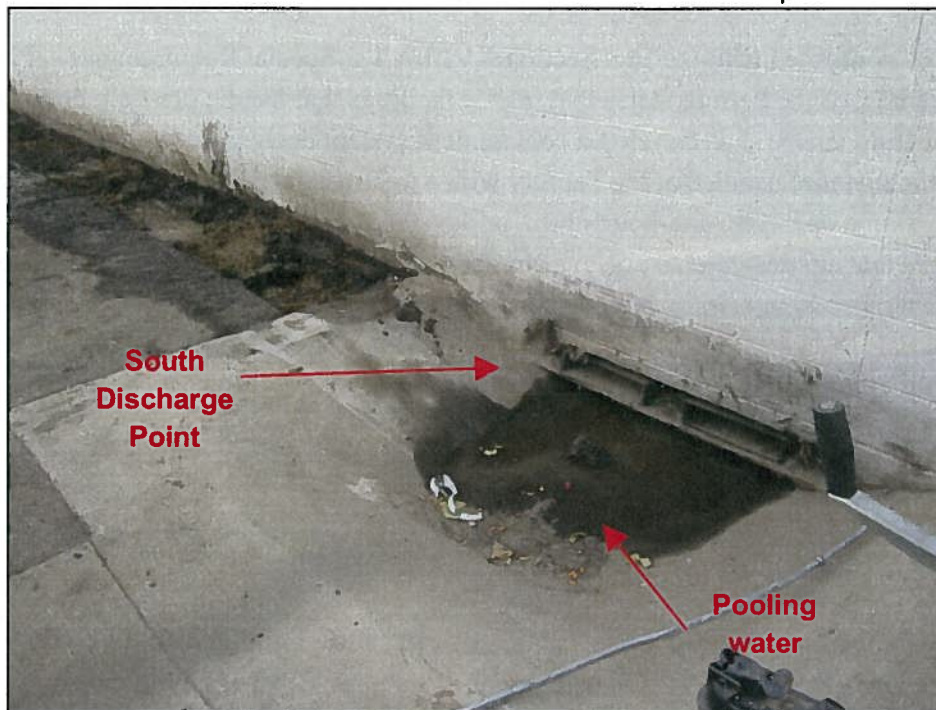
15. We observed that the Discharger had not fully implemented a containment system at the discharge points to trap plastic material and keep it from discharging offsite. Specifically, we observed that the Discharger had not deployed containment BMPs at the South Discharge Point or the Southeast Discharge Point at the Facility. Mr. Mendoza explained that the storm water and potential plastic pieces would likely settle at the South Discharge Point and thus would not discharge from the Facility (Photograph 1). However, this could

Photograph 1. View, facing south, of the South Discharge Point located at the southern area of the Facility. Note the pooling water in the discharge point.

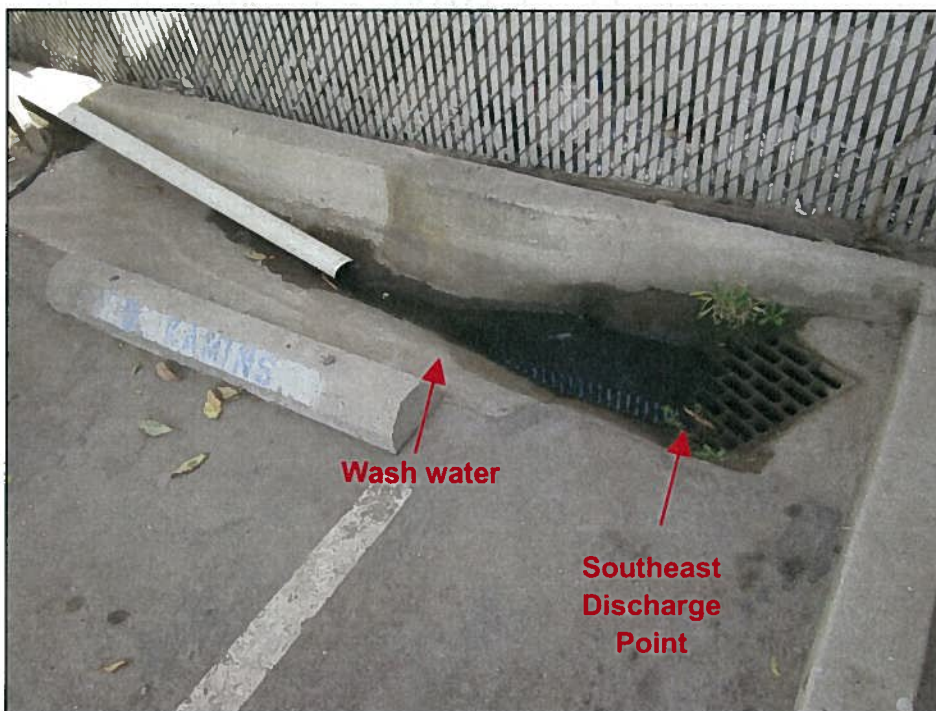
Photograph 2. View, facing northeast, of the Facility's Southeast Discharge Point located at the southeastern corner of the Facility.

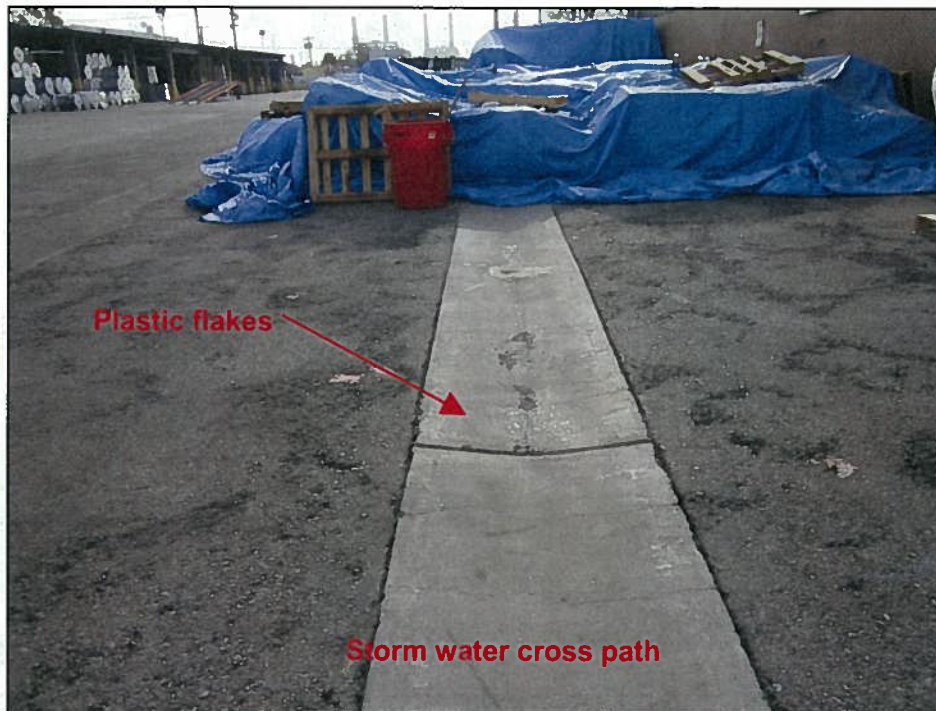
Yes/No	Comments
Good Housekeeping	No	We observed exposed plastic flakes that were uncovered and uncontained on the impervious surface of the Facility that could be mobilized during a storm event (Photographs 3 through 7).
	No	We observed oil staining on the impervious surface at

- d. *Structural storm water controls.* We observed a storm water cross path that ran along the western perimeter of the Facility and conveyed storm water either to the Northwest Discharge Point or the South Discharge Point (Photographs 3 and 4, 7, 15, and 16). The storm water cross path was not identified on the Facility site map.

Photograph 3. View, facing southeast, of the storm water cross path. Note the plastic flakes accumulated on the impervious surface within the storm water cross path.

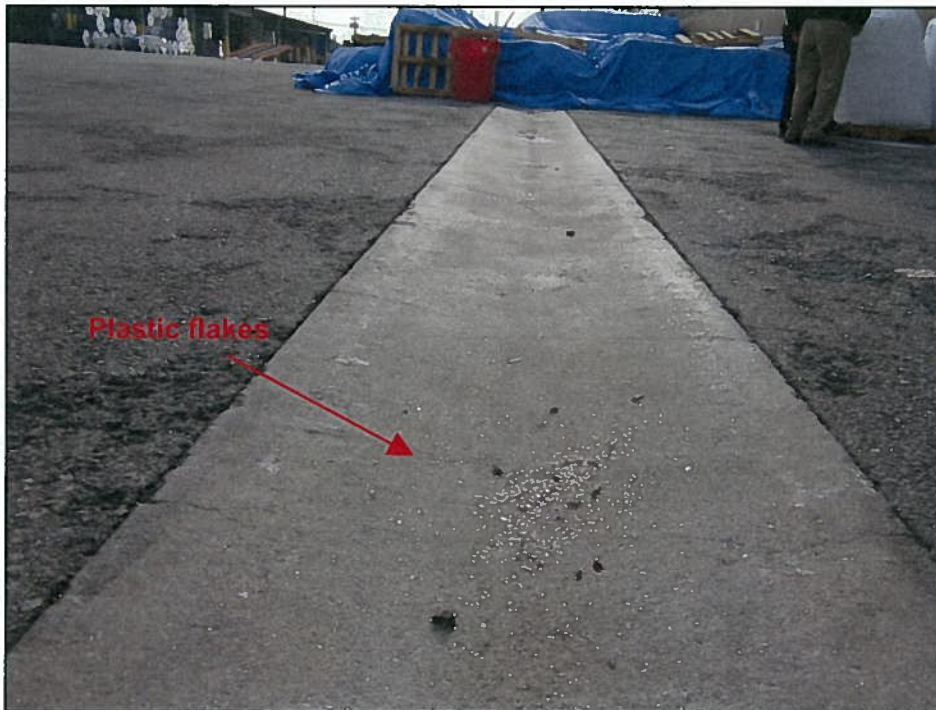
Photograph 4. Up-close view of the plastic flakes accumulated in the storm water cross path, depicted in Photograph 3, located near the western perimeter of the Facility.

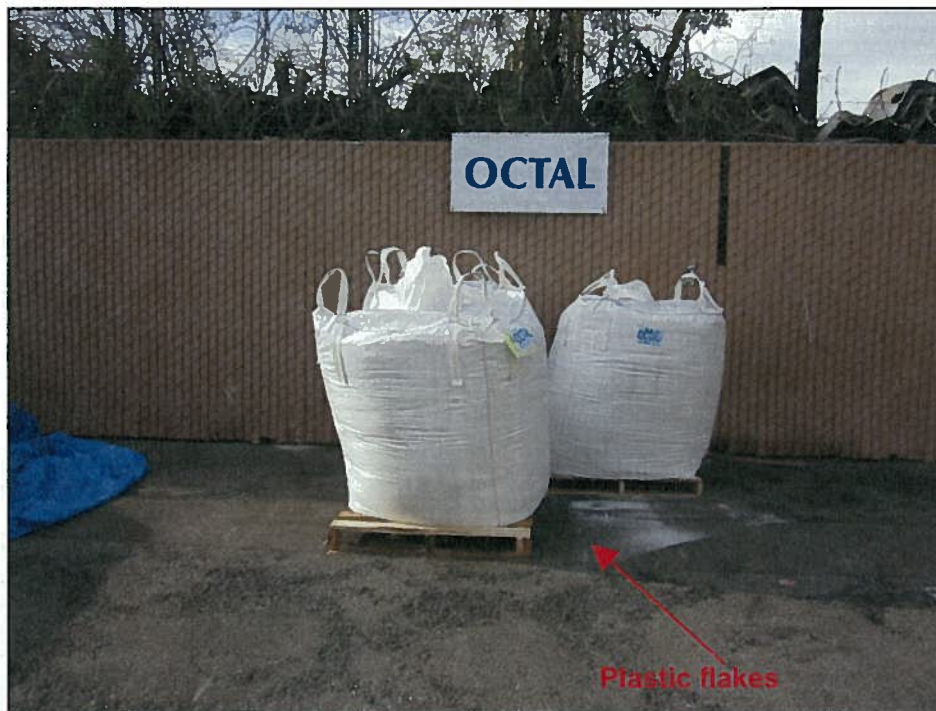
Photograph 5. View, facing west, of uncontained Supersacks of plastic flakes. Note the plastic flakes accumulated on the impervious surface beneath the Supersacks.

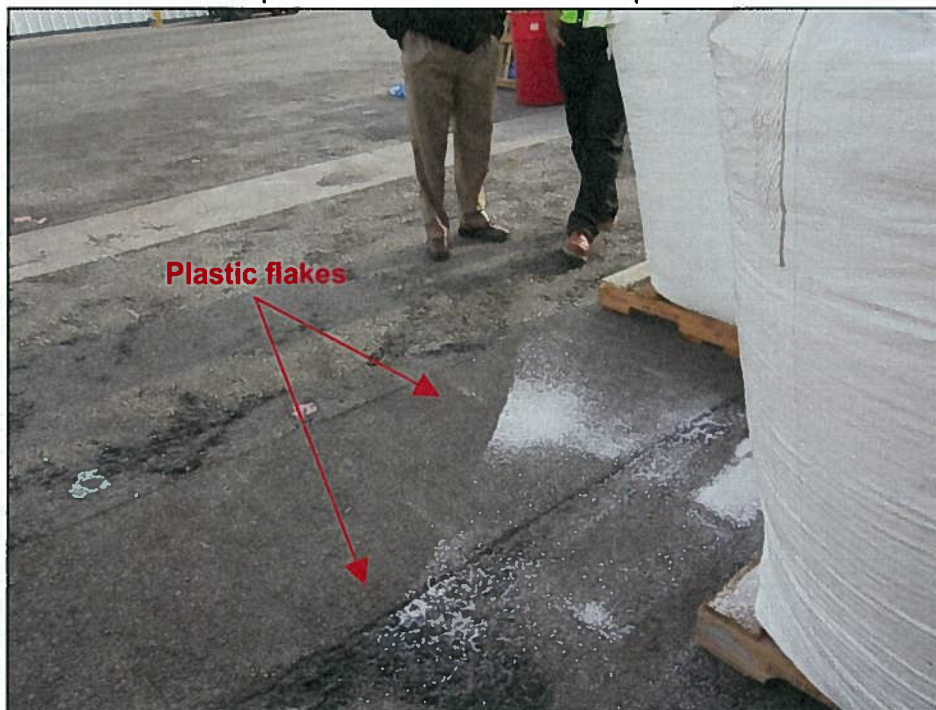
Photograph 6. Additional view of the uncontained plastic flakes accumulated on the impervious surface depicted in Photograph 5.

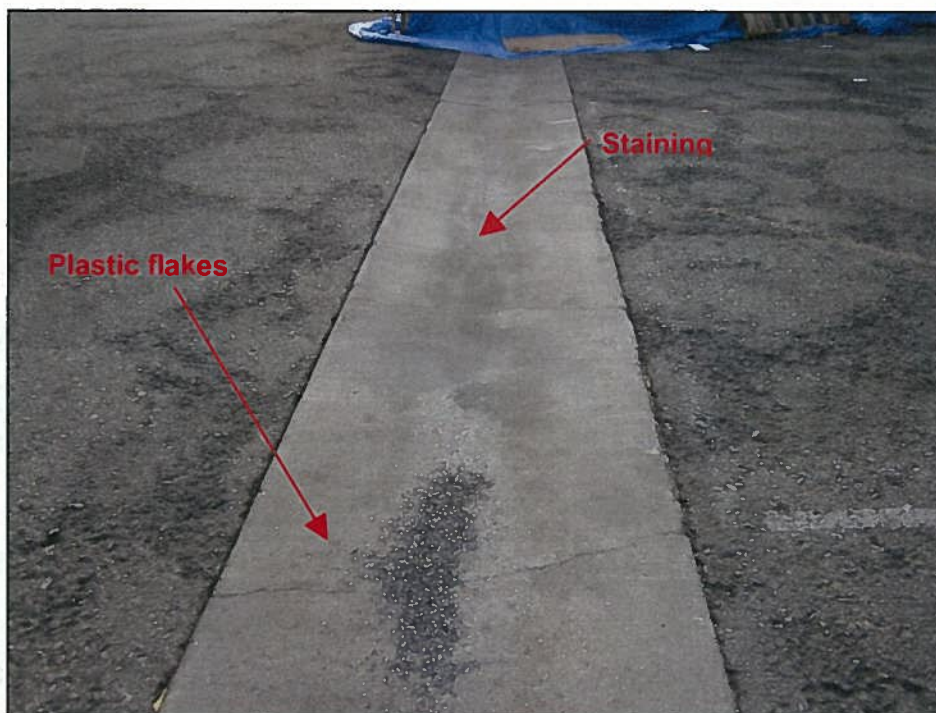
Photograph 7. View, facing southeast, of black plastic flakes accumulated within the storm water cross path, located near the central-western perimeter of the Facility. Note the unknown staining on the storm water cross path.

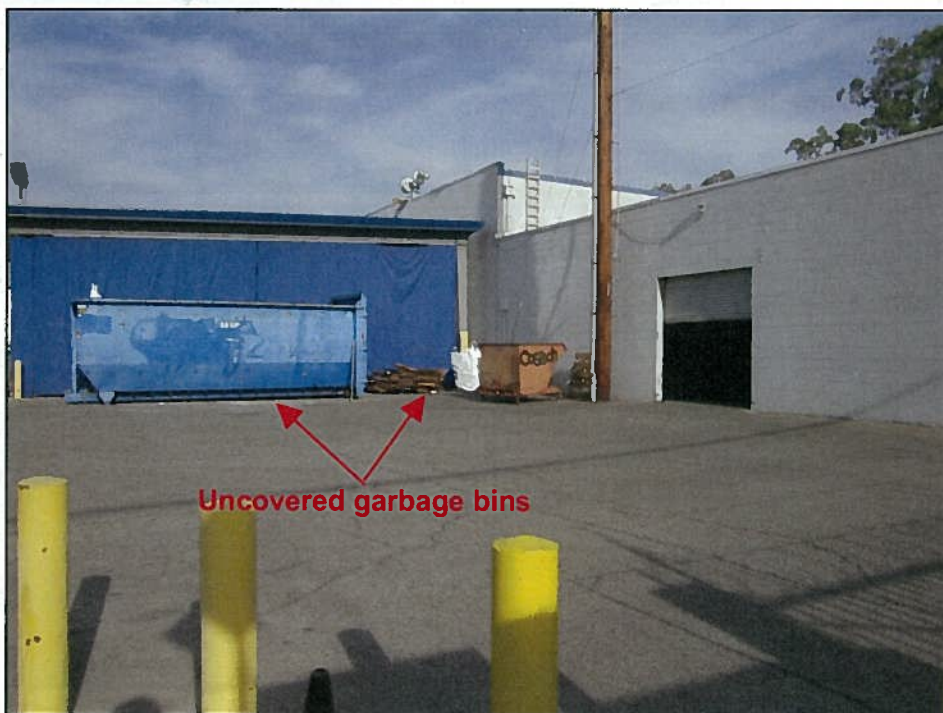
5. We observed that all materials handling and waste management BMPs had not been implemented at the Facility or addressed in the SWPPP per the Permit. Specifically, we observed two uncovered and uncontained garbage bins located in the southcentral area of the Facility (Photograph 8). Section X.H.1.d.iii, Material Handling and Waste Management Minimum BMPs, of the Permit, states that the Discharger shall cover industrial waste disposal containers and industrial material storage containers that contain industrial materials when not in use. SWPPP Section 5.G states that the trash bin is required to be in good conditions, leak proof and covered prior to and during expected rain events. We observed that the Discharger was not properly implementing the materials handling and waste management BMPs and that the SWPPP did not properly address these BMPs as required per Section X.H.1.d.iii of the Permit.

Photograph 8. View, facing north, of uncovered garbage bins located in the south-central area of the Facility.

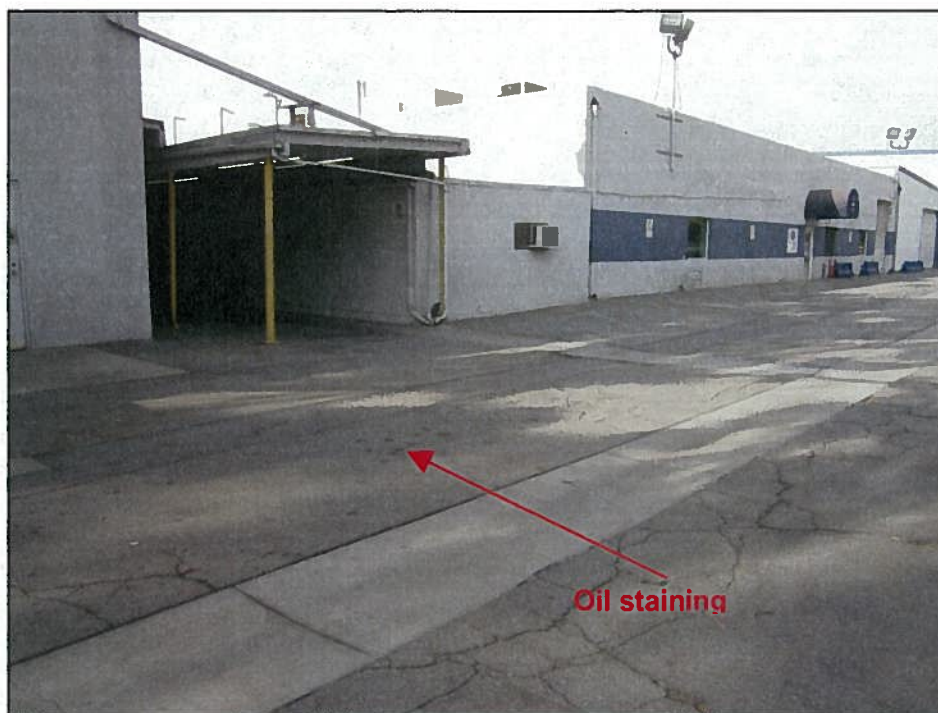
Preventative maintenance		the southeastern and southern areas of the Facility (Photographs 9 and 10).
Spill response	No	We observed uncovered and uncontained 55-gallon drums of emulsion chemicals at the northwestern perimeter of the Facility (Photograph 11).
Material handling and waste management	No	We observed uncovered and uncontained garbage bins at the southcentral area of the Facility (Photograph 8).
Erosion and sediment controls	Not Applicable (NA)	
Employee Training	Yes	
Quality assurance and recordkeeping	No	We observed that the Discharger did not maintain the monthly inspection records onsite at the time of the inspection.

3. We observed that procedures for prompt preventative maintenance activities had not been implemented at the Facility per the Permit. Specifically, we observed oil staining on the impervious surface at the southeastern and southern areas of the Facility (Photographs 9 and 10). Section X.H.1.b.iv, Preventive Maintenance Minimum BMPs, of the Permit, states that the Discharger shall establish procedures for prompt maintenance and repair of equipment, and maintenance of systems when conditions exist that may result in the development of spills or leaks. Due to the oil staining observed at the Facility, it appeared that the Discharger had not implemented procedures for prompt maintenance and repair

Photograph 9. View, facing northwest, of oil staining observed on the impervious surface at the southeastern area of the Facility.

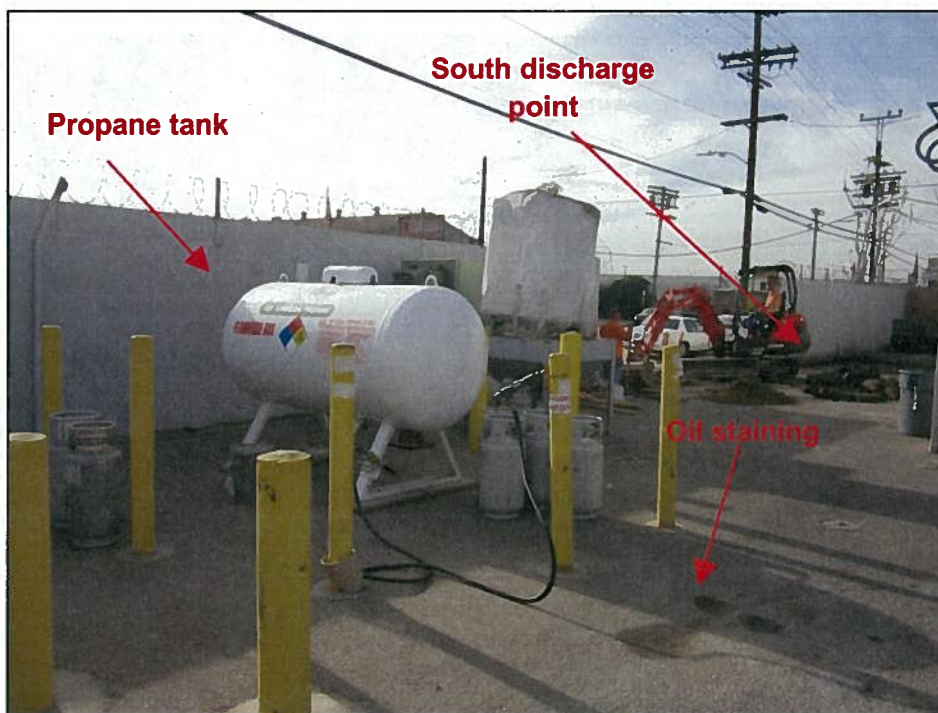
- g. *Fueling Areas.* We observed a propane tank located at the southern area of the Facility (Photograph 10). We observed that the Discharger depicted a storage area in this location on the Facility site map but did not specifically identify this location as a fueling area.

Photograph 10. View, facing southeast, of oil staining observed on the impervious surface at the southern corner of the Facility, near the propane tank, upgradient of the Facility's South Discharge Point.

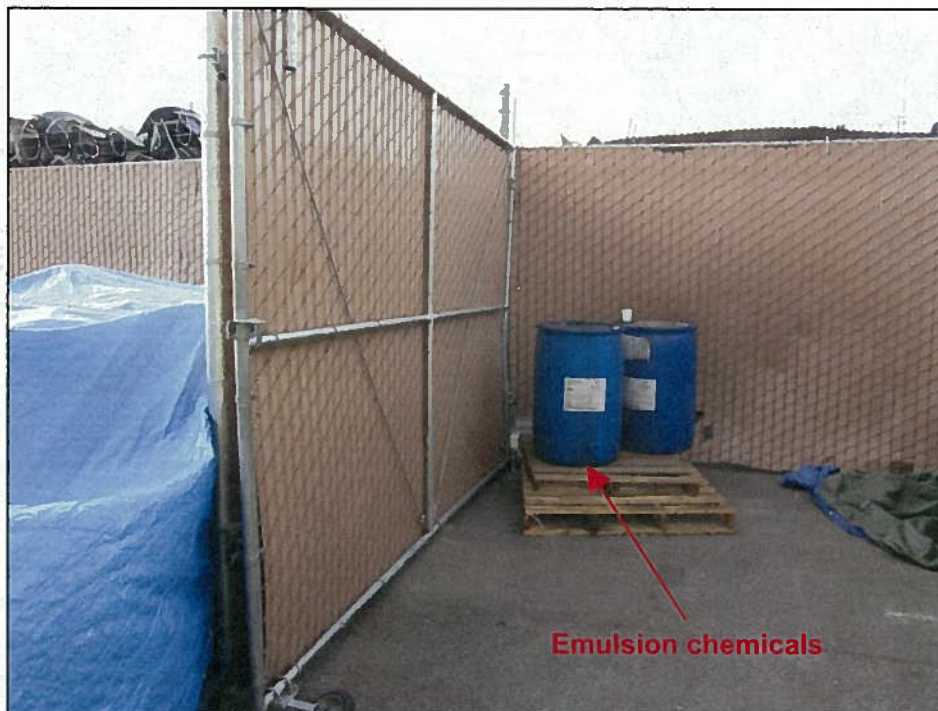
4. We observed that procedures for spill and leak prevention and response had not been implemented at the Facility per the requirements in the Permit. Specifically, we observed two 55-gallon drums of emulsion chemicals stored at the northwestern perimeter of the Facility without overhead coverage or containment (Photograph 11). We also observed multiple 5-gallon buckets of various chemicals including a protective film coating at the southern corner of the Facility without containment or overhead coverage (Photographs 12 and 13). Section X.H.1.c.i, Spill and Leak Prevention and Response Minimum BMPs, of the Permit, states that the Discharger shall establish procedures and/or controls to minimize spills and leaks. SWPPP Section 5.B states for material handling and storage, refer to Table 4-1. Table 4-1 is not identified in the SWPPP. From the conditions we observed onsite, the Discharger was not properly implementing spill and leak prevention and response procedures as required by Section X.H.1.c.i of the Permit.

Photograph 11. View, facing west, of two uncovered and uncontained 55-gallon drums of emulsion chemicals stored at the northwestern perimeter of the Facility.

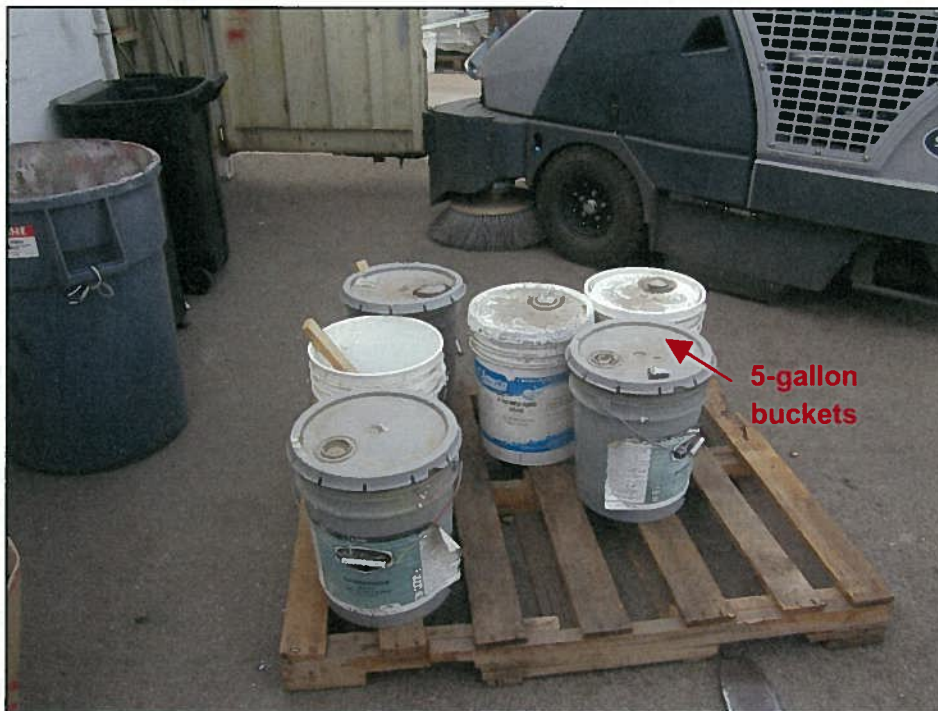
Photograph 12. View, facing south, of six uncovered and uncontained 5-gallon buckets of various chemicals, including a protective film chemical, stored at the southern corner of the Facility.

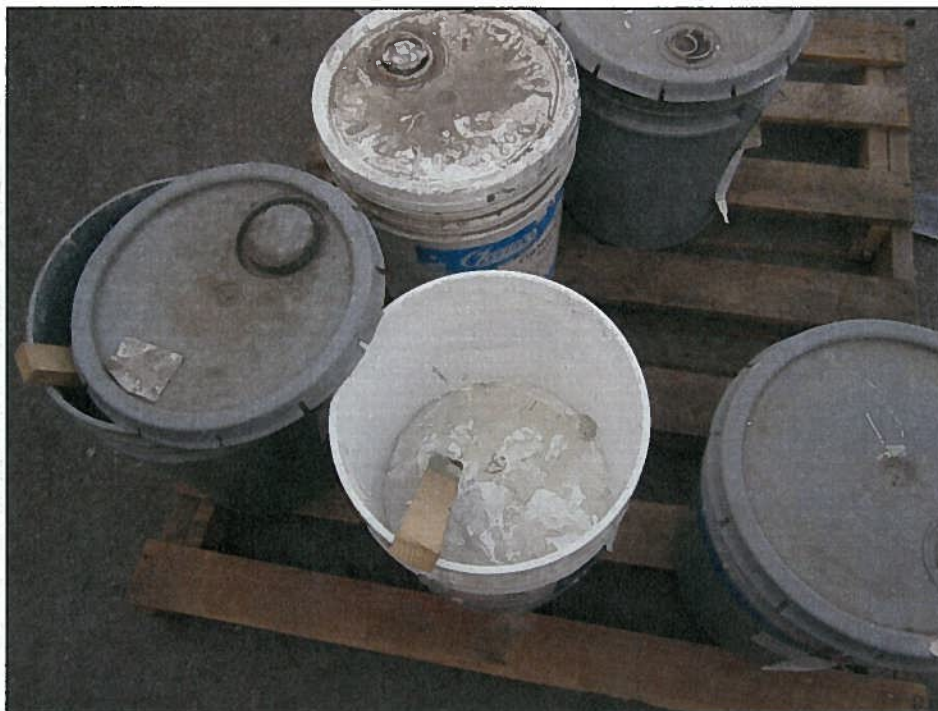
Photograph 13. Up-close view of the uncovered and uncontained 5-gallon buckets depicted in Photograph 12.

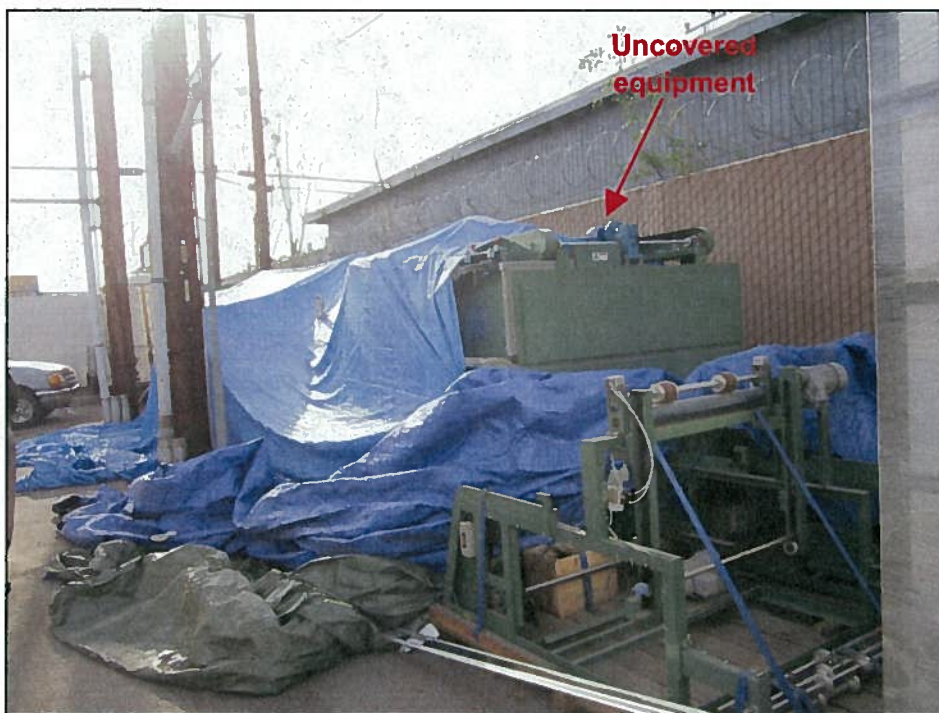
Photograph 14. View, facing south, of the partially uncovered, inactive equipment stored along the southwestern perimeter of the Facility, upgradient of the South Discharge Point.

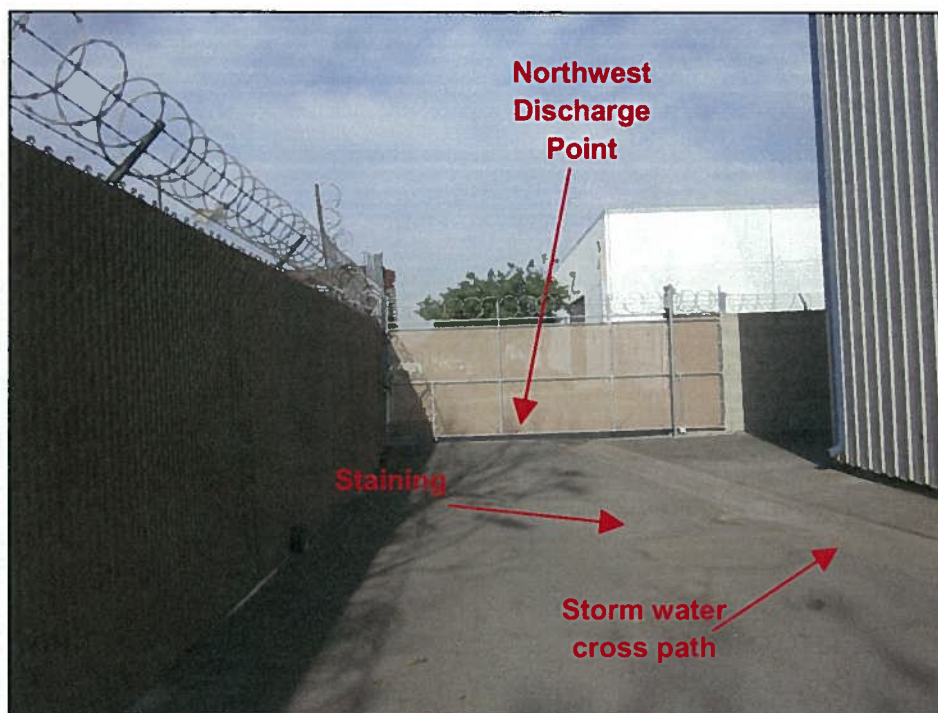
We then observed the Facility's Northwest Discharge Point and observed staining on the pavement in this area of the Facility (Photograph 15). We then inspected the inside of the production facility and proceeded to the northeastern perimeter of the Facility where we observed wash water flowing and collecting in a sump (Photographs 19 through 21). We observed that the wash water was pumped from the sump and conveyed via pipe to the Facility's Southeast Discharge Point (Photographs 22 and 23). We observed an unauthorized non-storm water discharge (NSWD) occurring from the Facility onto the curb and gutter line on Branford Street at the time of the inspection (Photographs 24 through 27).

Photograph 15. View, facing northwest, of the storm water cross path at the northwestern area of the Facility, leading to the Northwest Discharge Point at the northwestern corner of the Facility. Note the staining on the pavement.

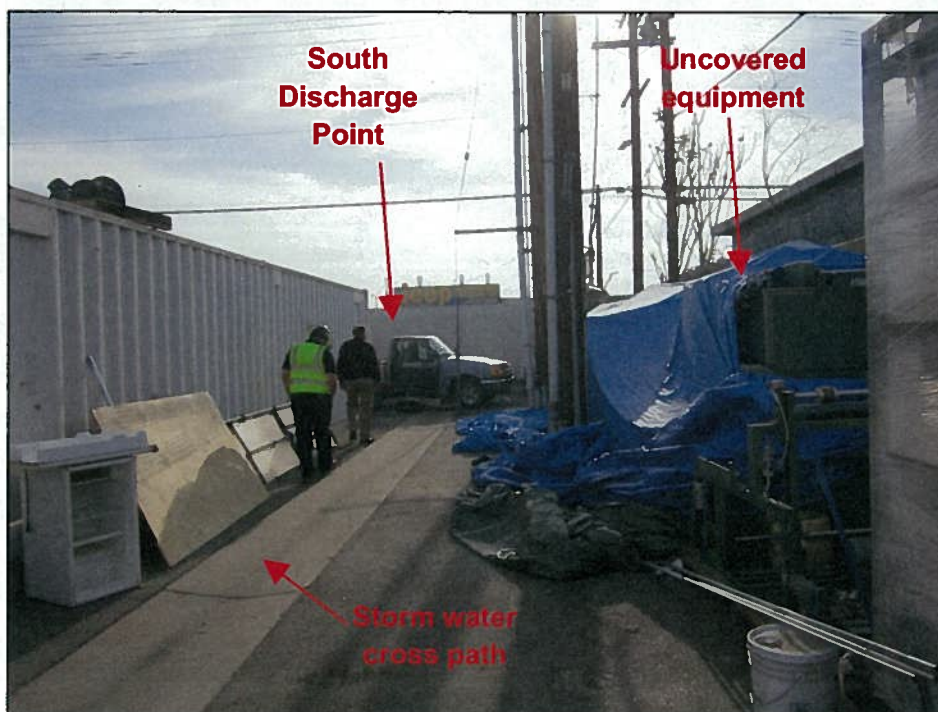
Photograph 16. View, facing southeast, of the Facility's storm water cross path that runs along the western perimeter of the Facility to the South Discharge Point.

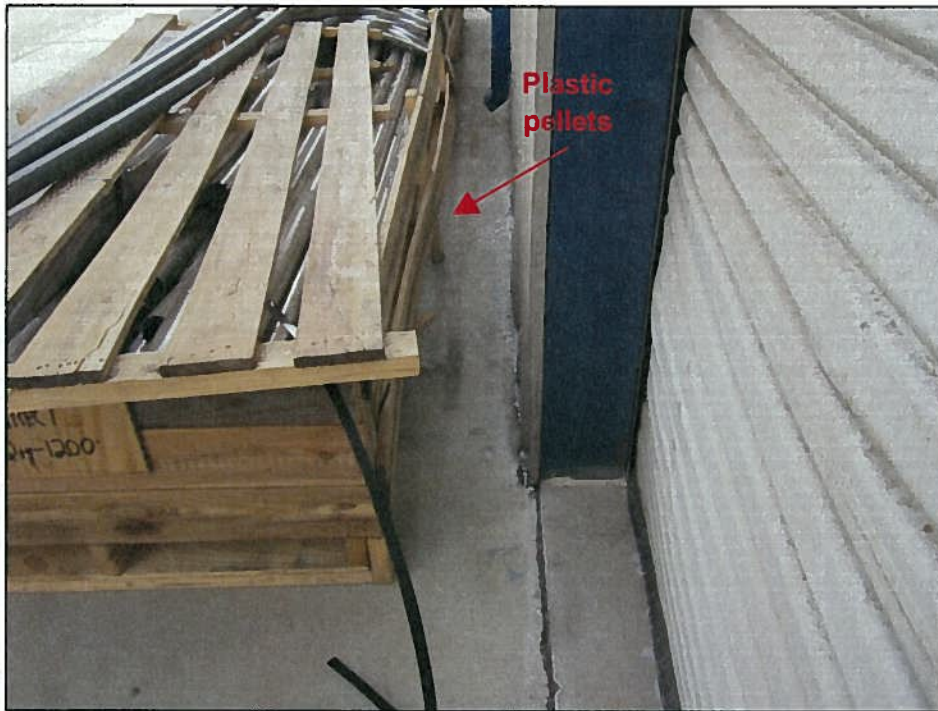
- e. *Location of directly exposed materials.* We observed that the Discharger identified storage areas on the Facility site map but did not specifically identify these areas as location where directly exposed materials were stored. We observed several locations with directly exposed materials during the inspection. Specifically, we observed uncontained plastic flakes in the storm water cross path (Photographs 3 through 7), partially uncovered equipment (Photograph 16), and uncontained plastic pellets at the northern corner of the Facility (Photographs 17, 18, and 28).

Photograph 17. View of directly exposed plastic pellets at the northern corner of the Facility, south of the plastic storage silos.

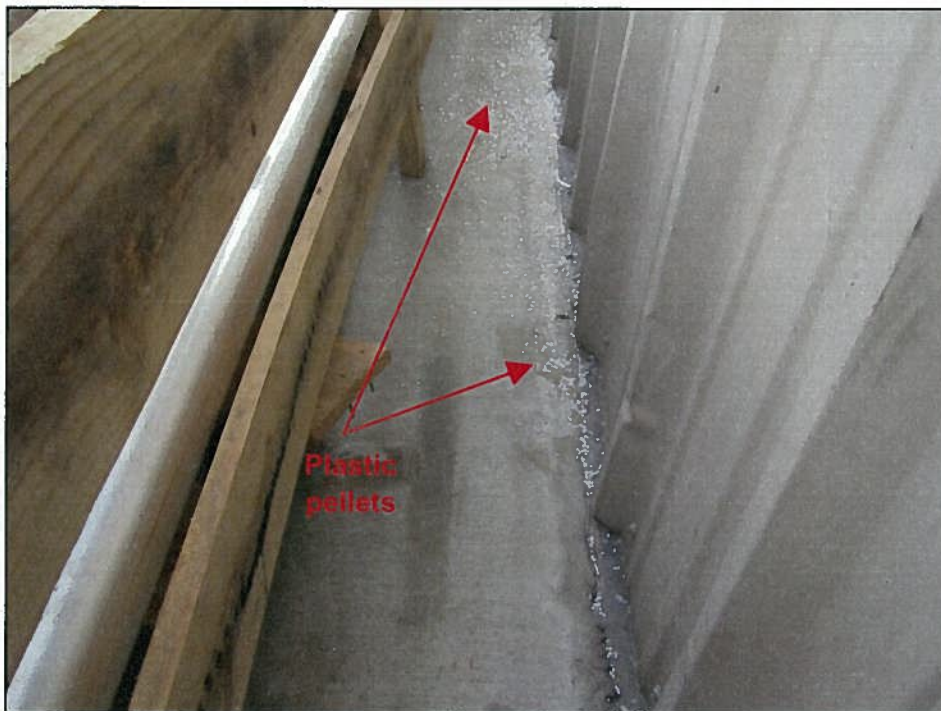
Photograph 18. Up-close view of the directly exposed plastic pellets at the northern corner of the Facility as shown in Photograph 17.

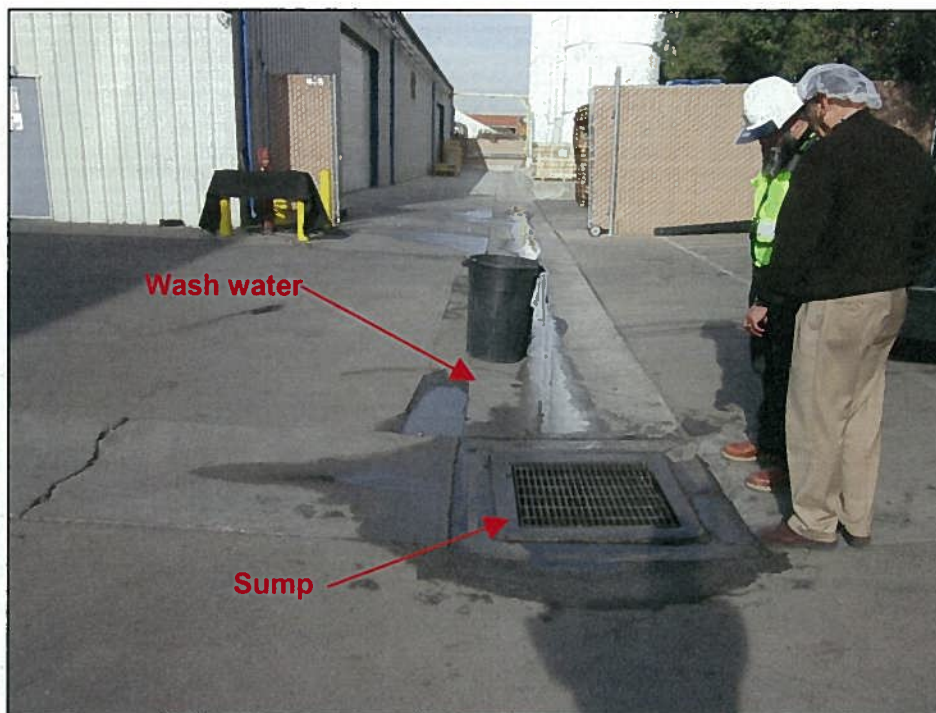
We observed floor mat cleaning occurring at the northeastern perimeter of the Facility, to the east of the production building. Soapy wash water was being generated from this process and was flowing toward and collecting within a nearby sump (Photographs 19 and 20). We observed an oily sheen on the surface of the wash water within the sump (Photograph 21). Mr. Mendoza explained that the wash water collects in the sump and that a float activated pump within the sump conveys the water via a pipe to the Facility's Southeast Discharge Point (Photograph 22). Mr. Mendoza explained that the sump was intended to be used to transport storm water to the Southeast Discharge Point. We then proceeded to the Southeast Discharge Point and observed the wash water flowing from the sump to the Southeast Discharge Point, through an unknown conveyance pipe and onto Branford Street (Photographs 23 through 27). We observed the wash water (NSWD) from the Facility accumulating in the curb and gutter line and flowing down Branford Street. Section I.C.28, Discharge Prohibitions, of the Permit, states that prohibited NSWDs are referred to as unauthorized NSWDs in the general permit. Unauthorized NSWDs may contribute significant pollutant loads to receiving waters. Measures to control sources of unauthorized NSWDs such as spills, leakage, and dumping, must be addressed through the implementation of BMPs. The Discharger had not deployed effective BMPs onsite to mitigate the potential for an unauthorized NSWD of wash water to occur at the Facility per Section I.C.28 of the Permit.

Photograph 19. View, facing northwest, of the area used for floor mat cleaning near the northeastern perimeter of the Facility. This area was not identified as a cleaning area on the Facility site map. Note the wash water collecting in the sump.

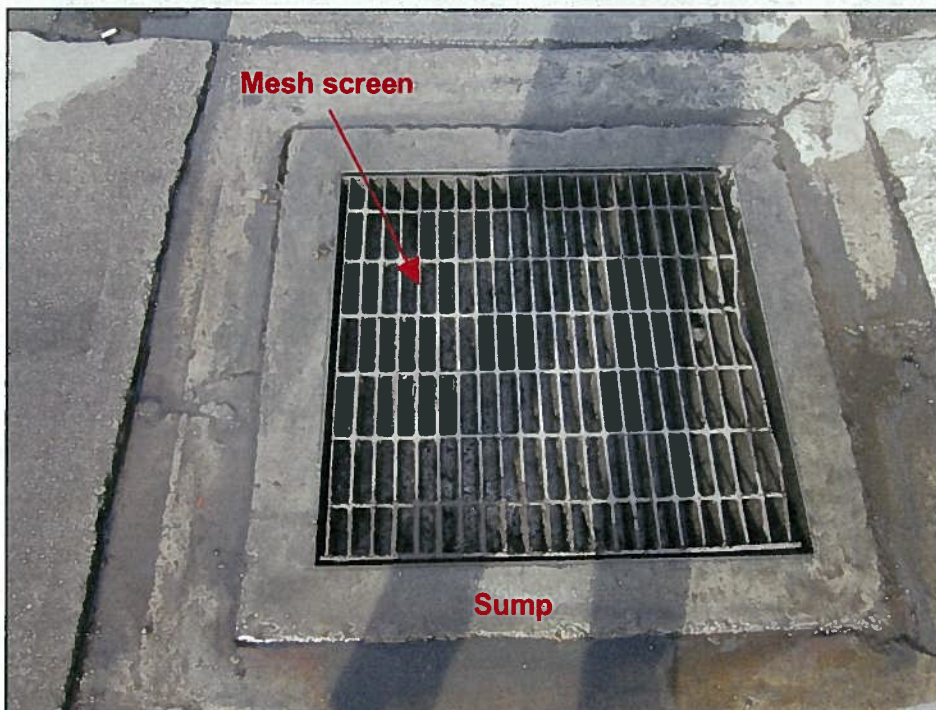
Vacuum system(s) available?	Yes	
Containment system or alternative for plastics materials < 1mm in size	No	We observed that the Discharger had installed a mesh screen in the sump at the northeastern perimeter of the Facility (Photograph 20). We also observed that the Discharger had not implemented a containment system designed to trap the plastic particles at the Southeast Discharge Point or the South Discharge Point (Photographs 1 and 2).

Photograph 20. Up-close view of the sump located near the northeastern perimeter of the Facility, depicted in Photograph 19. Note the mesh screen applied to the sump.

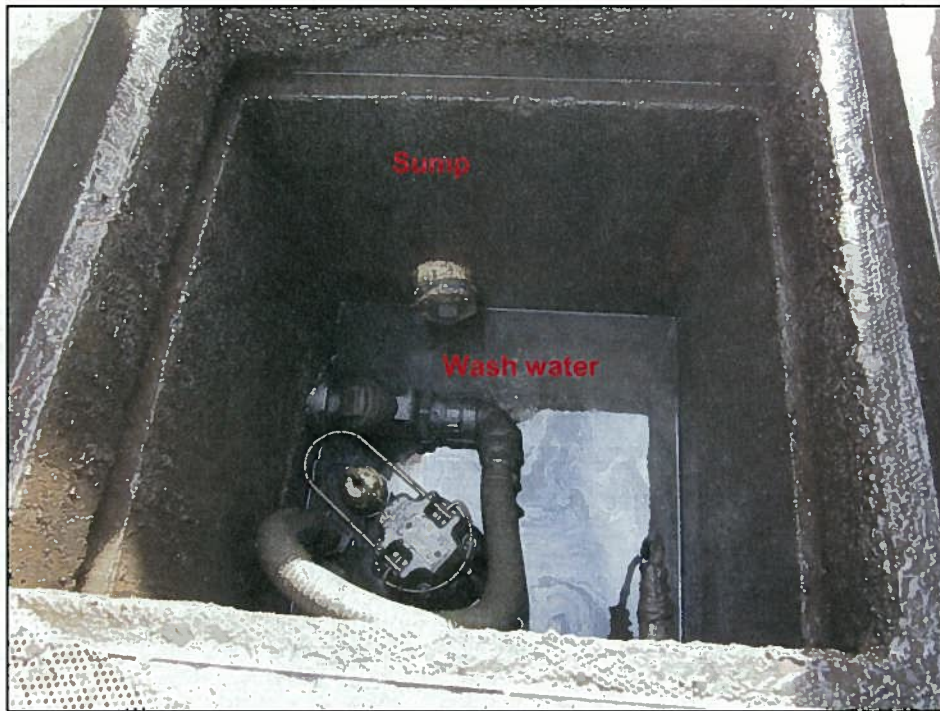
Photograph 21. Up-close view inside of the sump, depicted in Photographs 19 and 20. Note the sheen on the accumulated wash water within the sump.

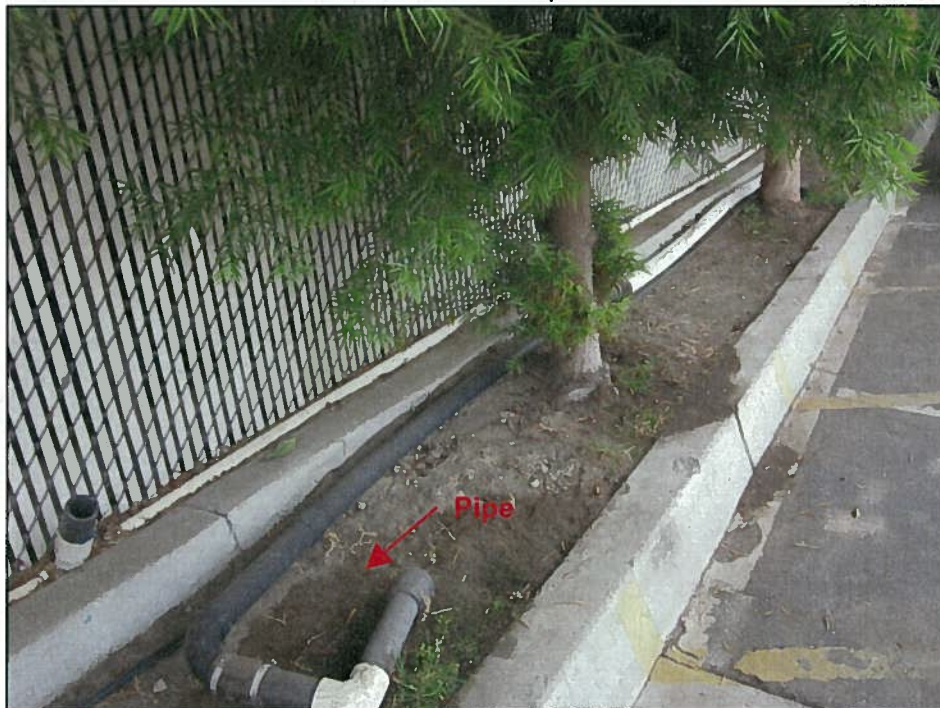
Photograph 22. View, facing southeast, of the pipe that conveys water from the sump at the east-central perimeter of the Facility to the Southeast Discharge Point depicted in Photographs 2 and 23.

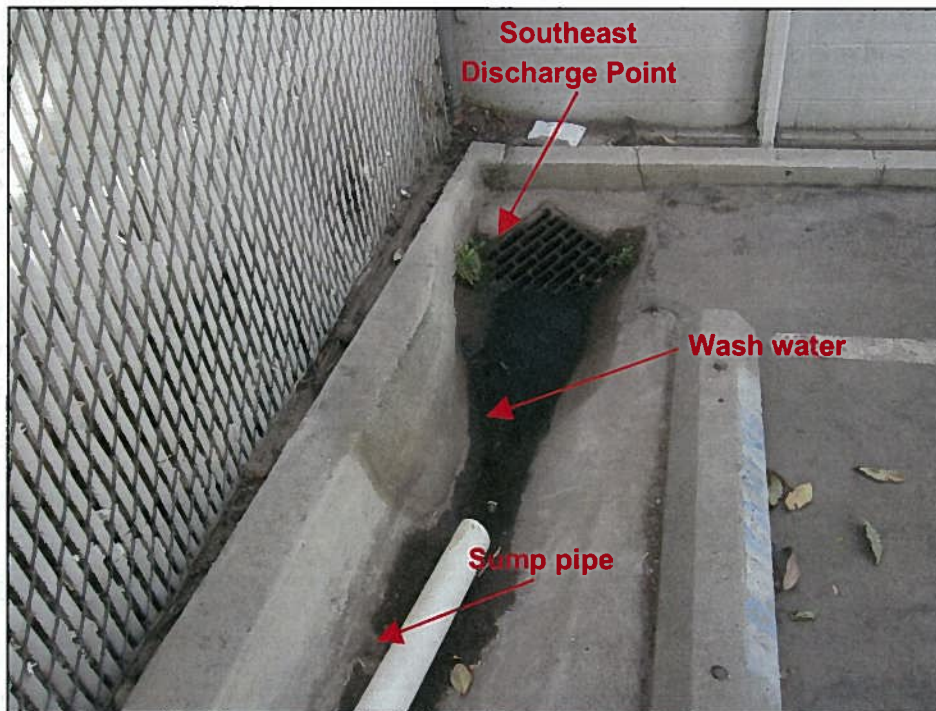
Photograph 23. View, facing southeast, of the Southeast Discharge Point, depicted in Photograph 2. Note the unauthorized NSW of wash water actively occurring at the time of the inspection.

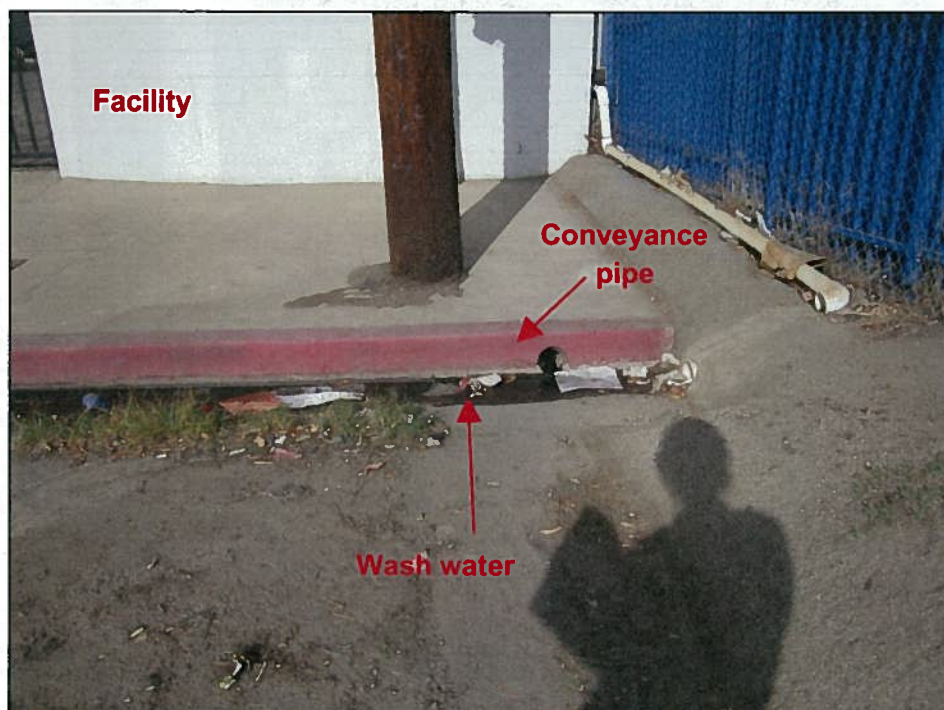
Photograph 24. View, facing north, of an unknown conveyance pipe leading from the southeastern corner of the Facility into the gutter of Branford Street.

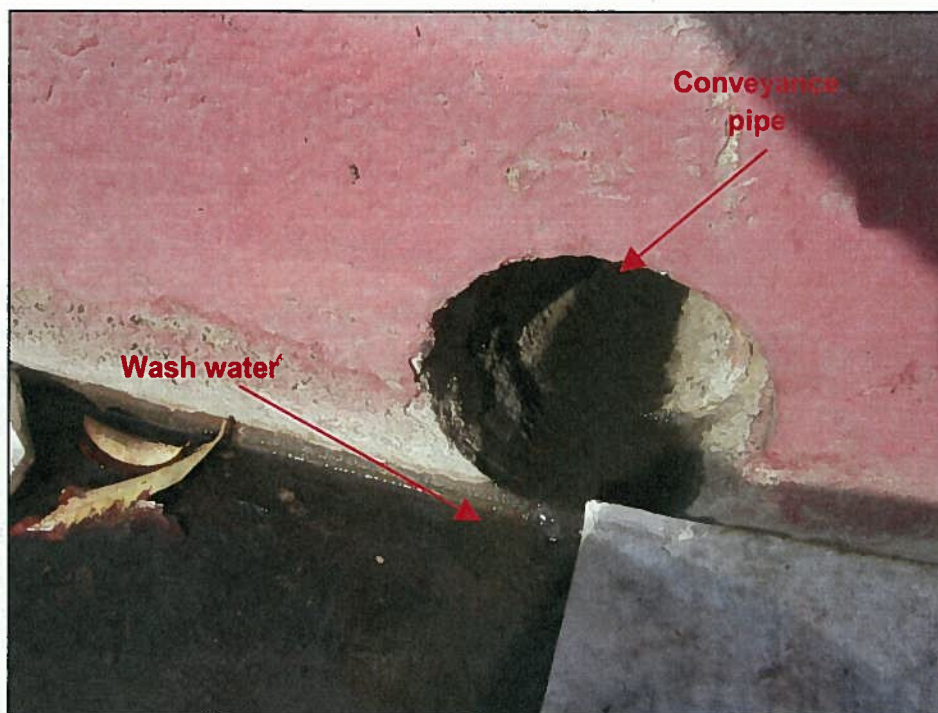
Photograph 25. Up-close view of wash water discharging from the unknown conveyance pipe leading from the Facility onto the gutter of Branford Street, as shown in Photograph 24.

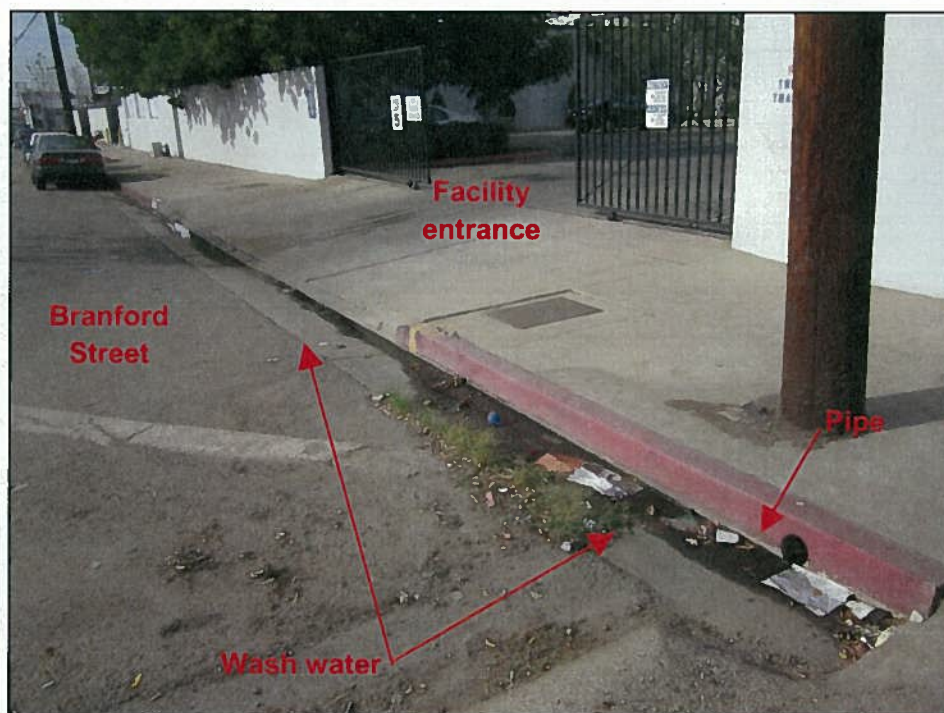
Photograph 26. View, facing west, of the wash water from the Facility accumulating in the curb and gutter line on Bradford Street.

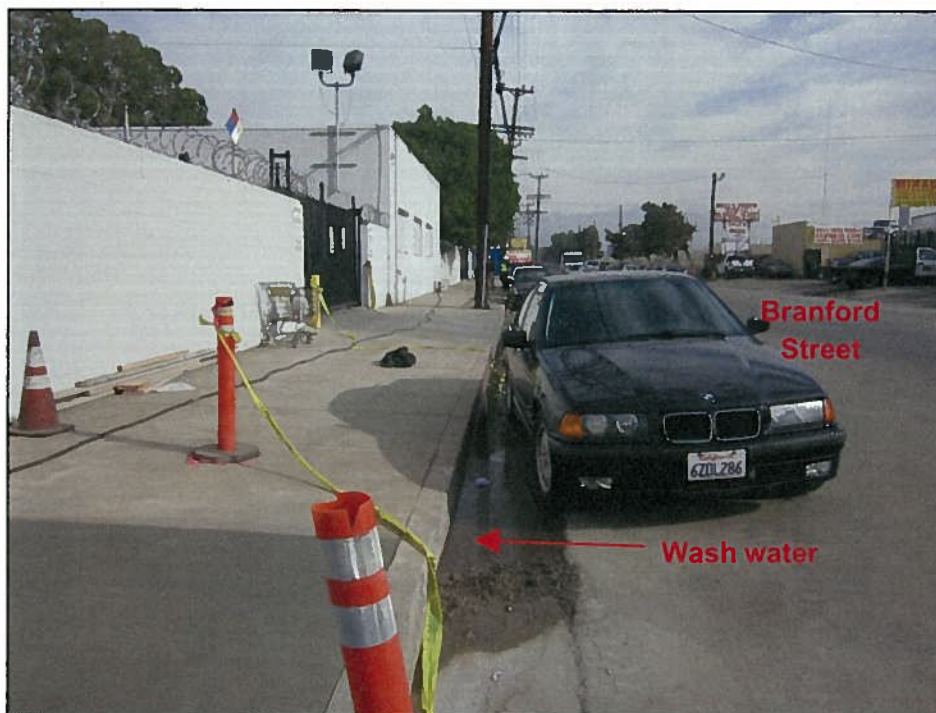
Photograph 27. View, facing east, of the wash water discharged from the Facility accumulating in the curb and gutter line on Bradford Street.

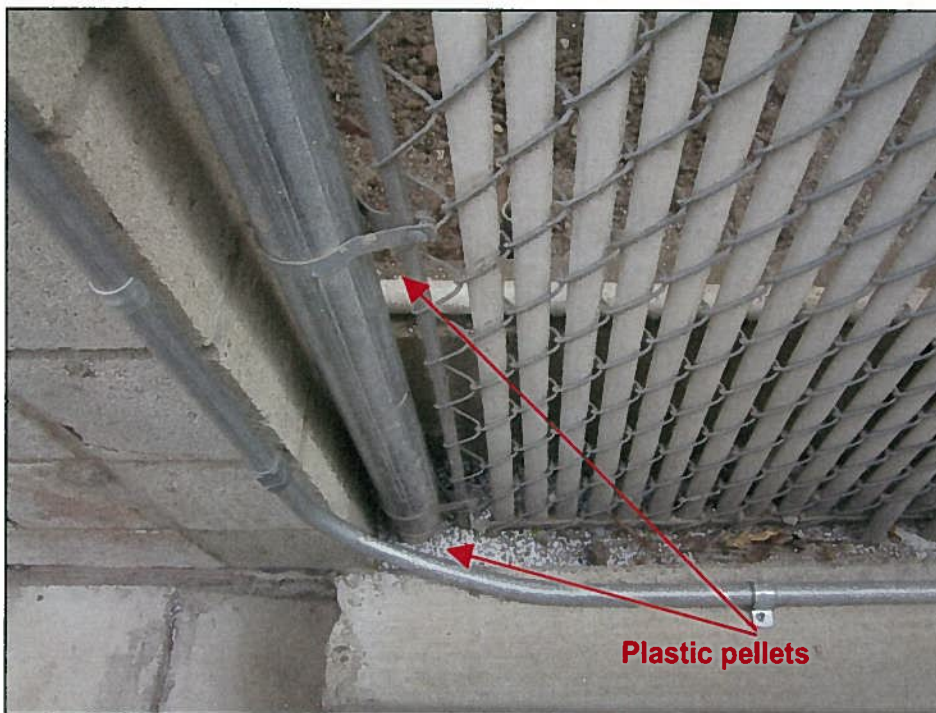
Photograph 28. View, facing east, of plastic pellets collected on the impervious surface near the northern corner of the Facility. Note the uncontained plastic pellets outside of the Facility's chain-linked fence line.
